PEPPERTREE BAY BLDG 25

RESERVE STUDY

July 2024
Report Prepared By:

DYNAMIC ENGINEERING
DESIGN & INSPECTION

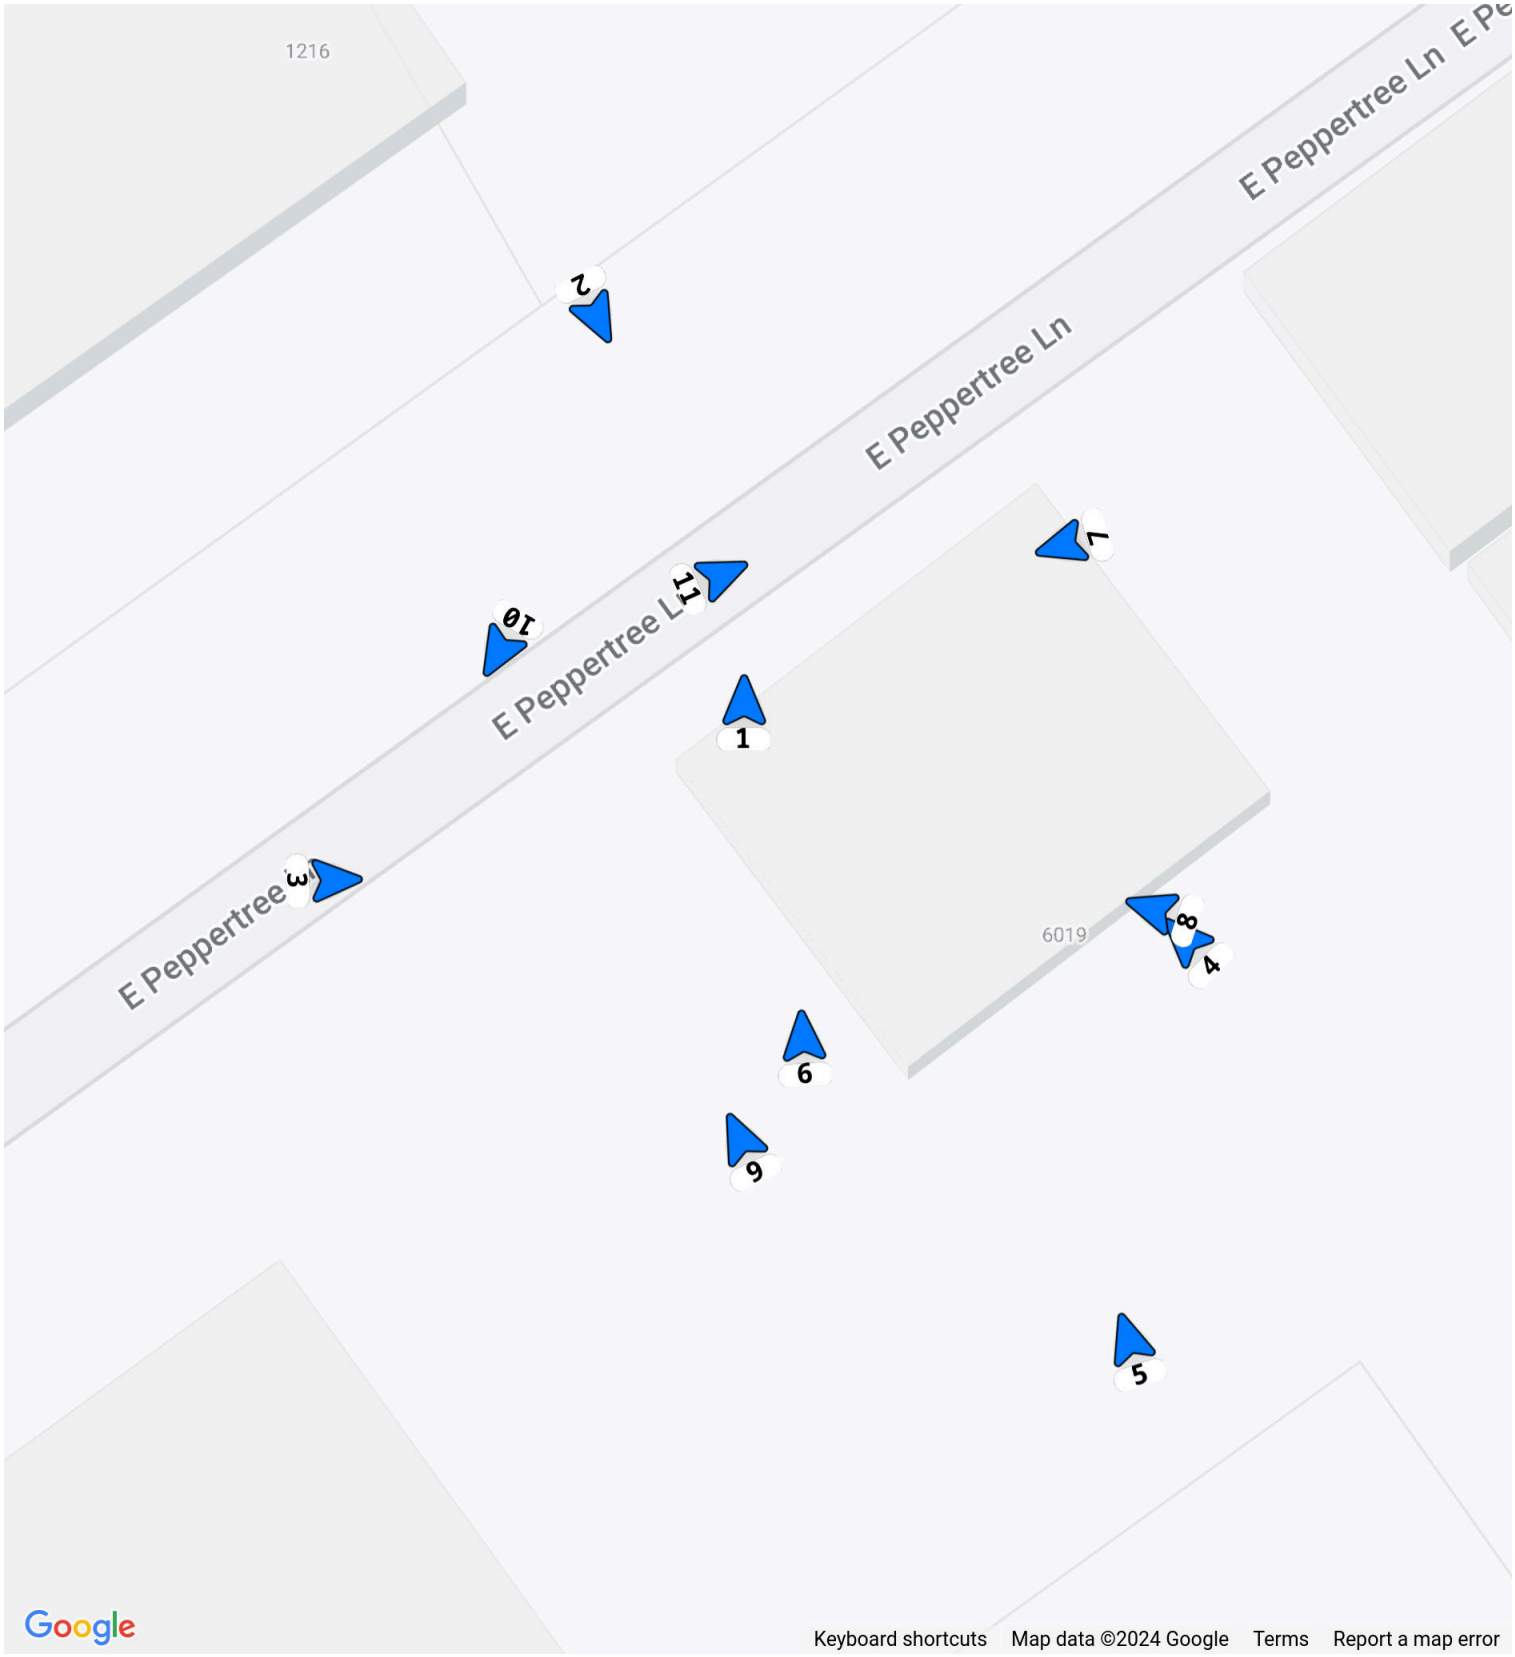
Media 1: Roof Overview

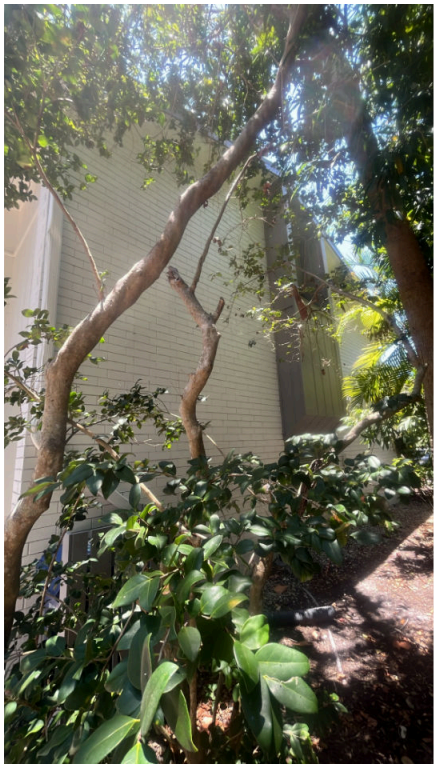
Media 8: Building 25, side elevation adjacent to unit 1214.

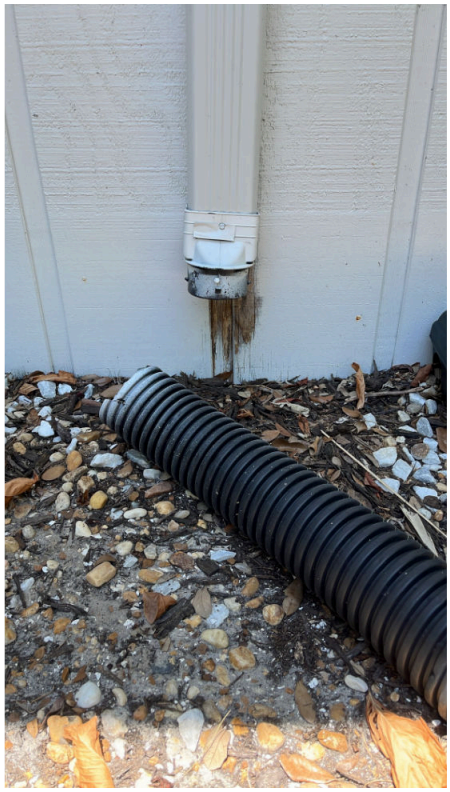
Media 9: Building 25, between units 1212 and 1214, deteriorated wood panel siding at the base of a disconnected downspout
