PEPPERTREE BAY BLDG 37

RESERVE STUDY

July 2024
Report Prepared By:

DYNAMIC ENGINEERING
DESIGN & INSPECTION

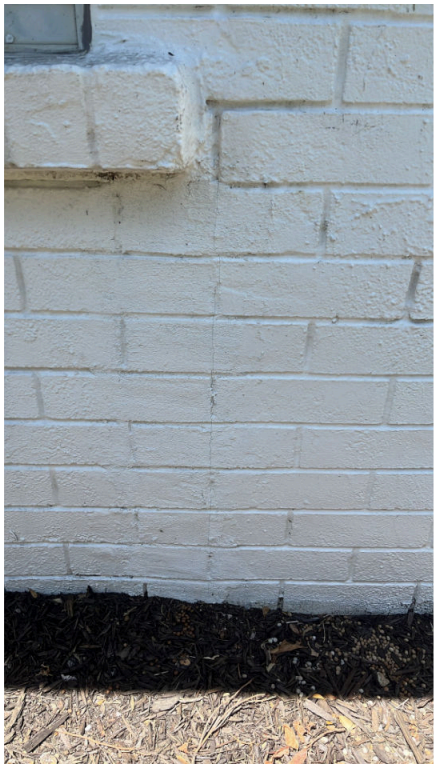
Media 8: Building 37, narrow crack in veneer, side elevation 1160 and 1158.

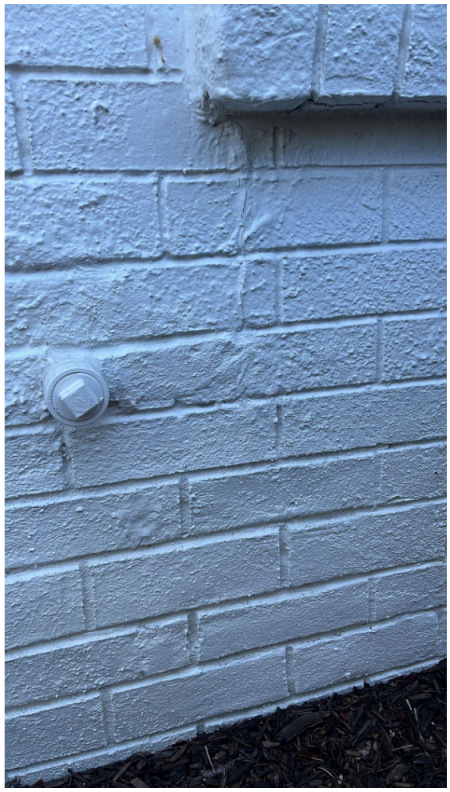
Media 9: Building 37, unit 1154, crack starting at sill, previously patched.

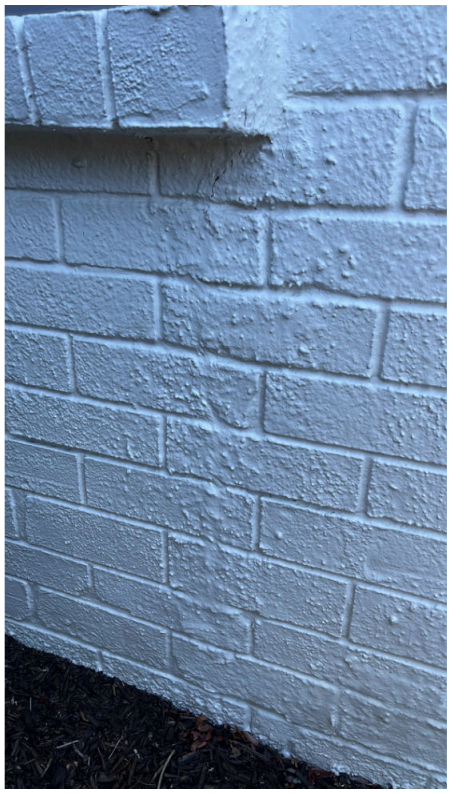
Media 11: Building 37, unit 1154. Crack below the windowsill and also below the architectural bump-out.
