PEPPERTREE BAY BLDG 38

RESERVE STUDY

July 2024
Report Prepared By:

DYNAMIC ENGINEERING
DESIGN & INSPECTION

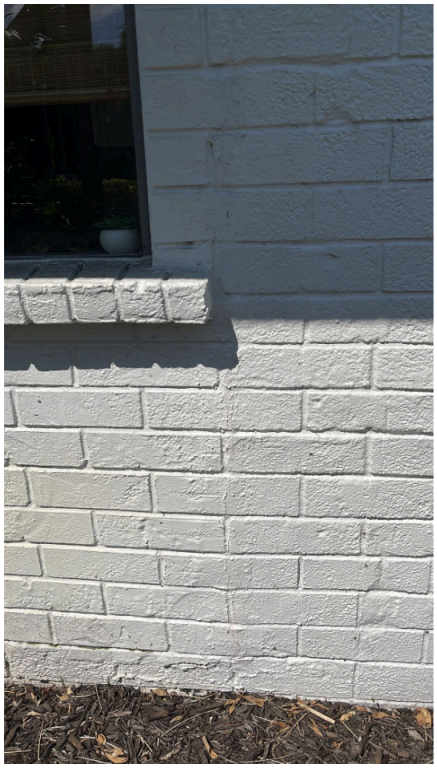
Media 8: Building 38 narrow crack in veneer with some slight bulging adjacent to units 1166 and 1168

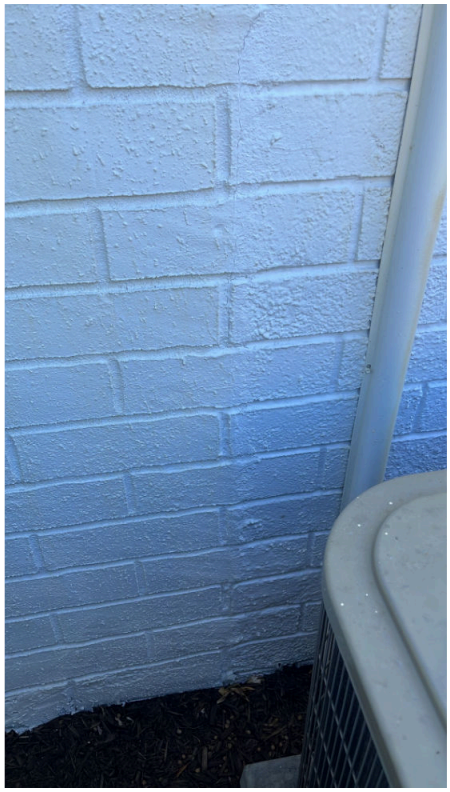
Media 9: Building 38, units 1162 and 1164, crack in the veneer, length is from the corner of the architectural bump out to ground elevation.
