PEPPERTREE BAY BLDG 47

RESERVE STUDY

July 2024
Report Prepared By:

DYNAMIC ENGINEERING
DESIGN & INSPECTION

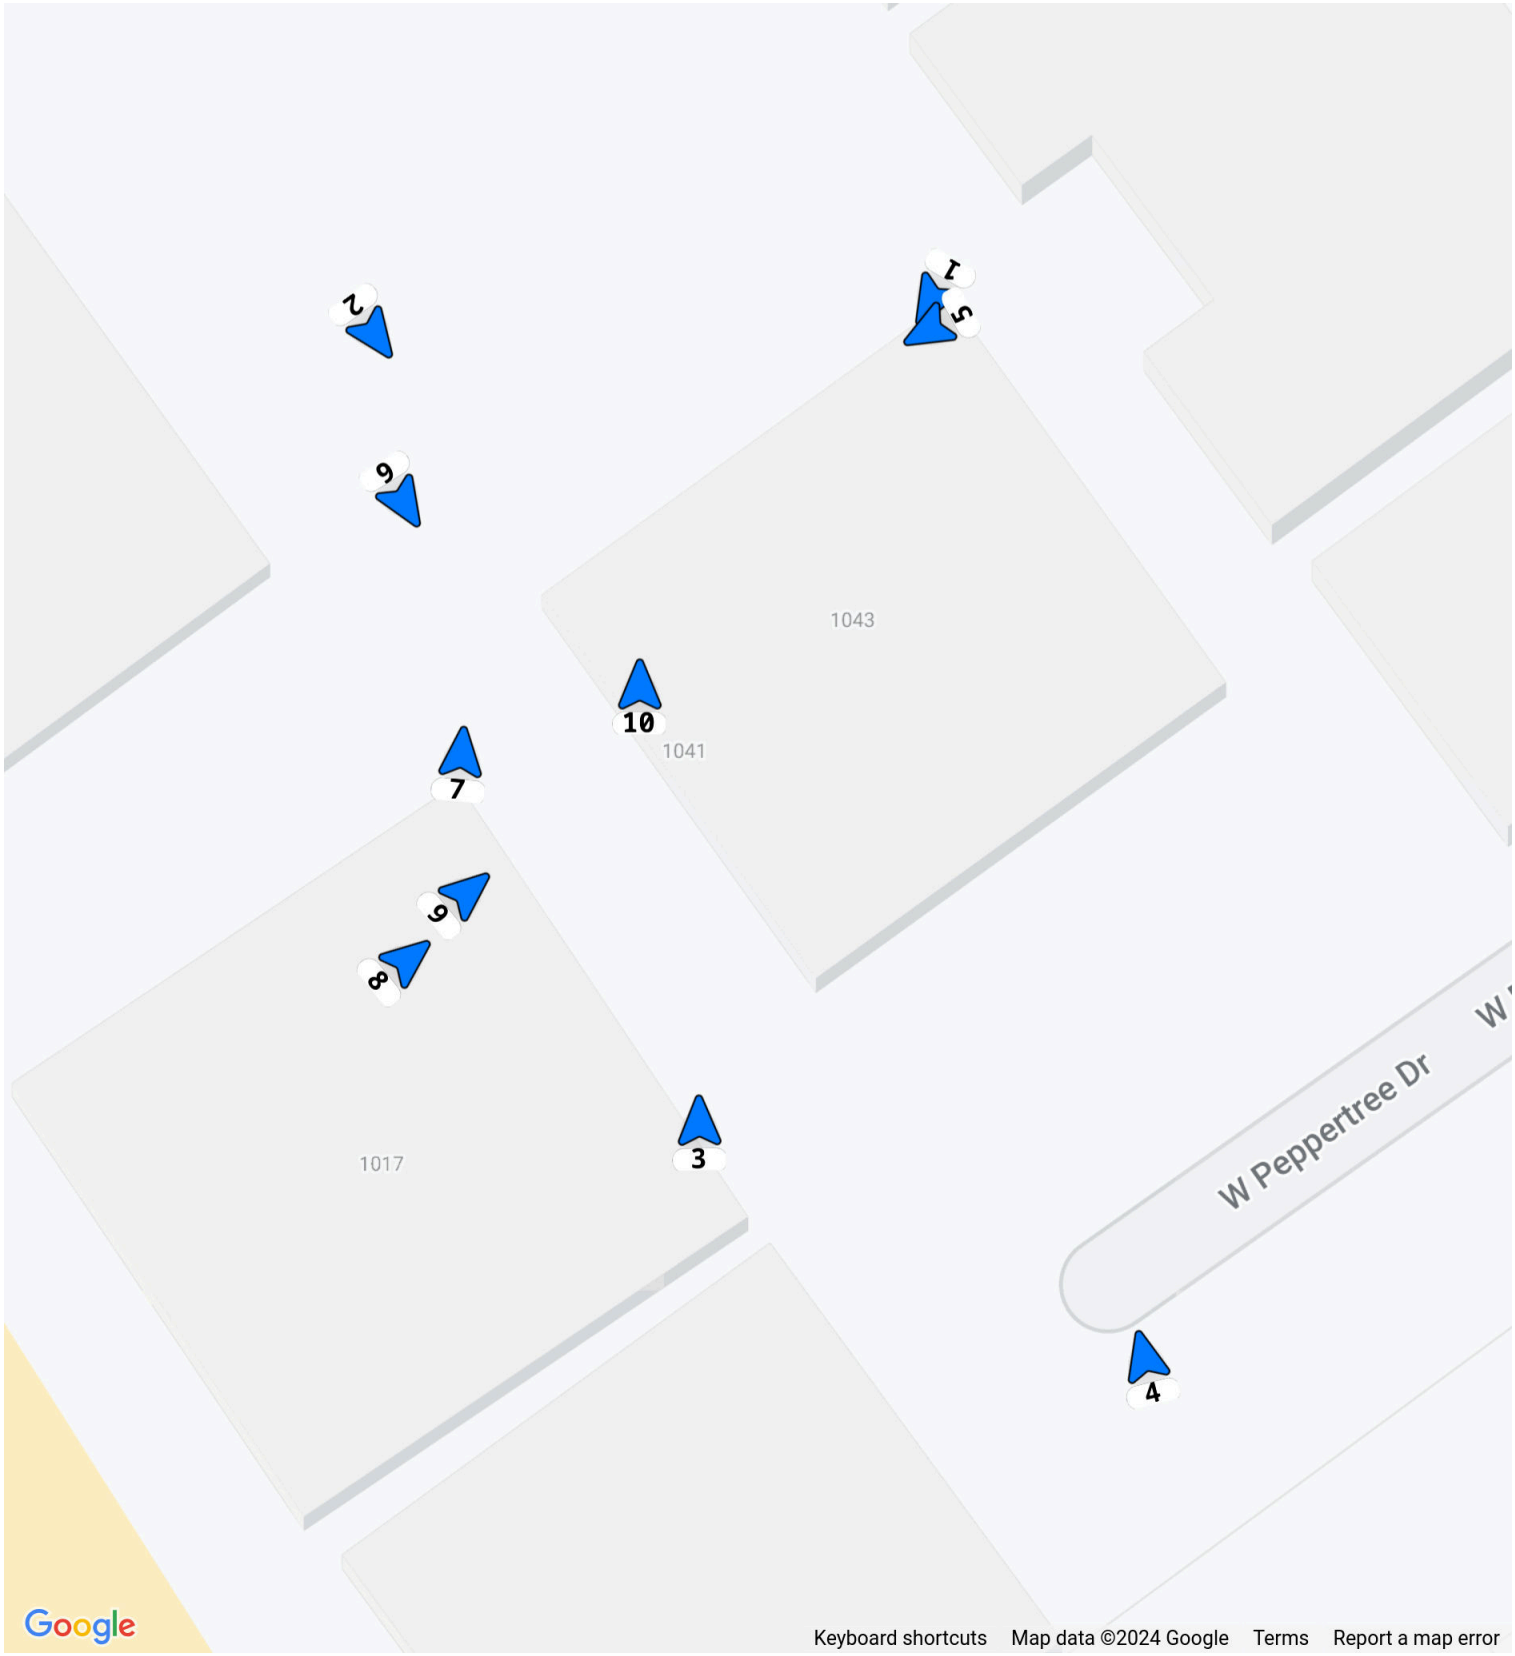
Media 1: Building 47. Units 1043 and 1045, side elevation.

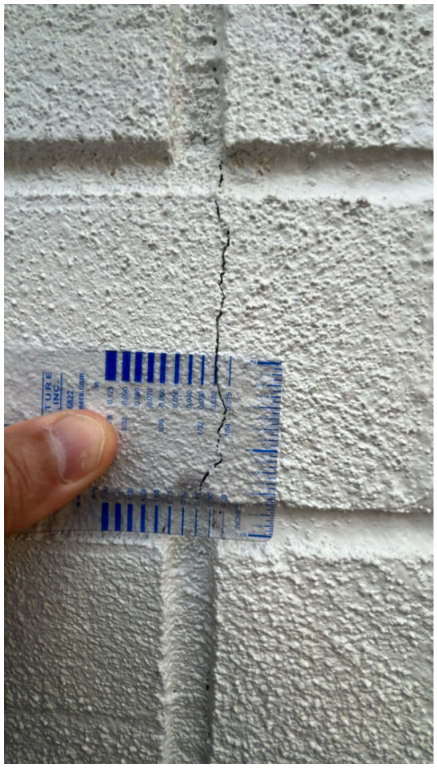
Media 8: Building 47 unit 1037 and 1041 cracks about a quarter of the height. They begin at the flowerbed moving up about a quarter of the height of the wall. 0.030” crack width
