PEPPERTREE BAY BLDG 49

RESERVE STUDY

July 2024
Report Prepared By:

DYNAMIC ENGINEERING
DESIGN & INSPECTION

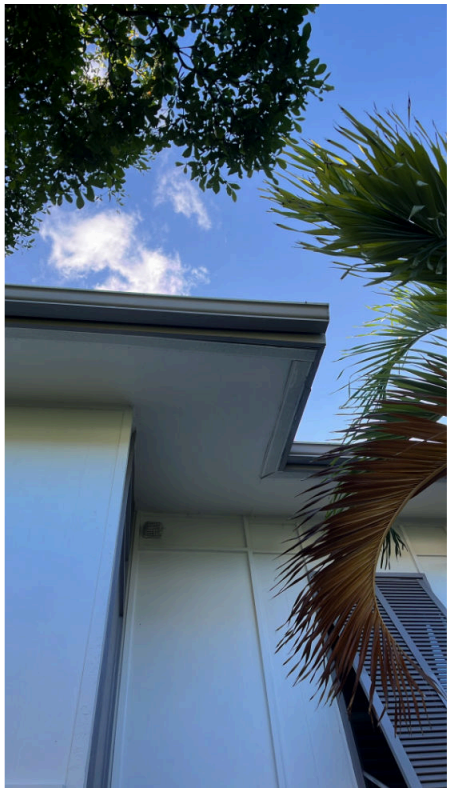
Media 11: Building 49, Unit 6019, corner of the roof appears to be sagging a little bit.
