PEPPERTREE BAY BLDG 50

RESERVE STUDY

July 2024
Report Prepared By:

DYNAMIC ENGINEERING
DESIGN & INSPECTION

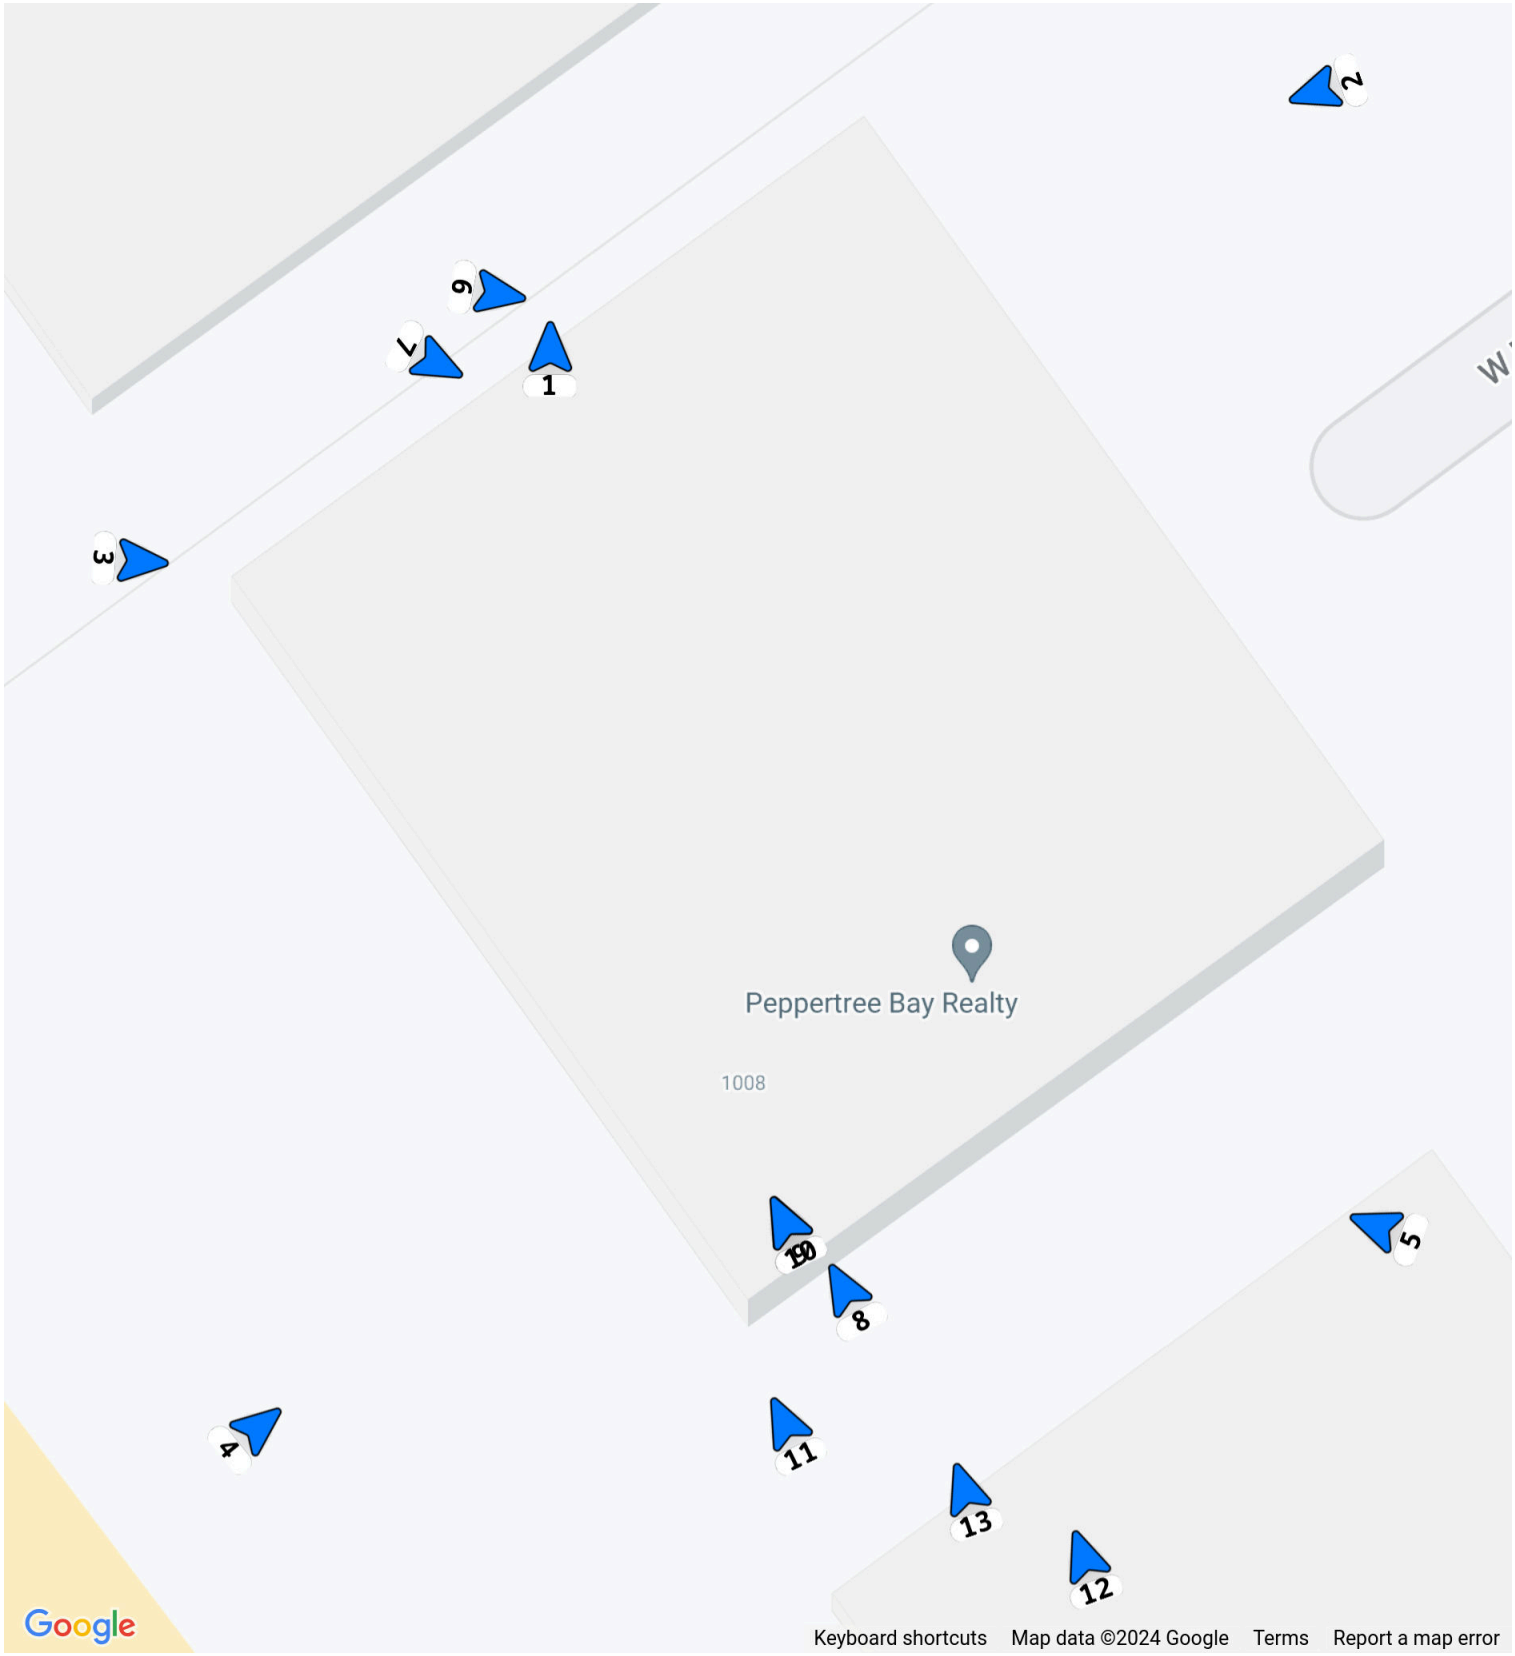
Media 1: Roof Overview

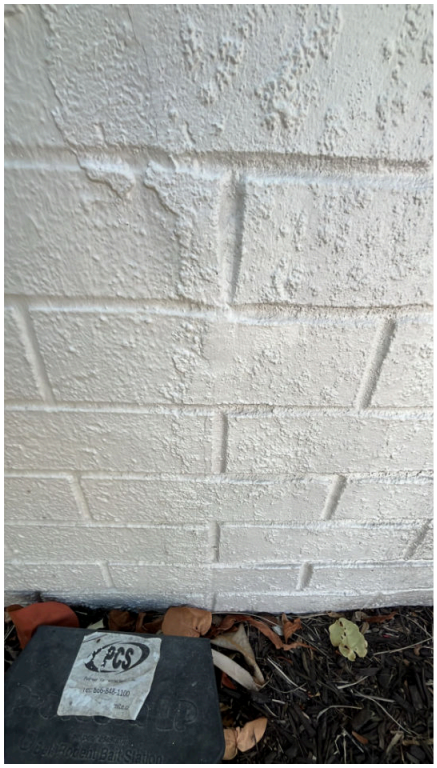
Media 8: Building 50, unit 1008, crack in wall reflecting through a previous repair near the architectural bump-out

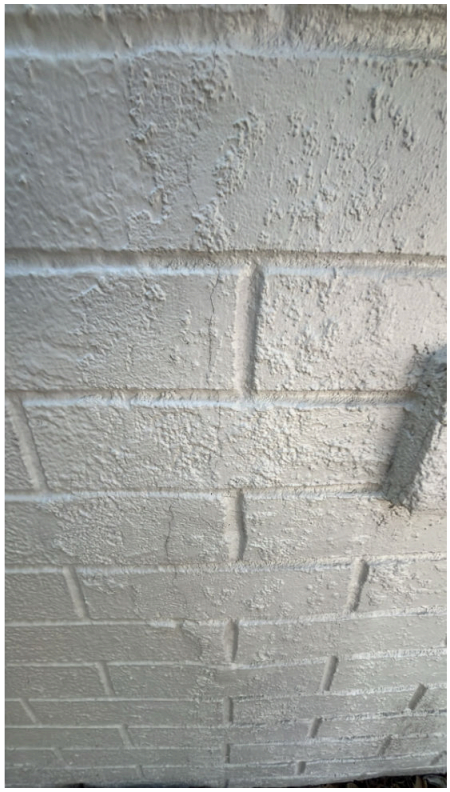
Media 9: Building 50, unit 1008, crack in wall reflecting through a previous repair near the architectural bump-out (opposite side of previous photo)

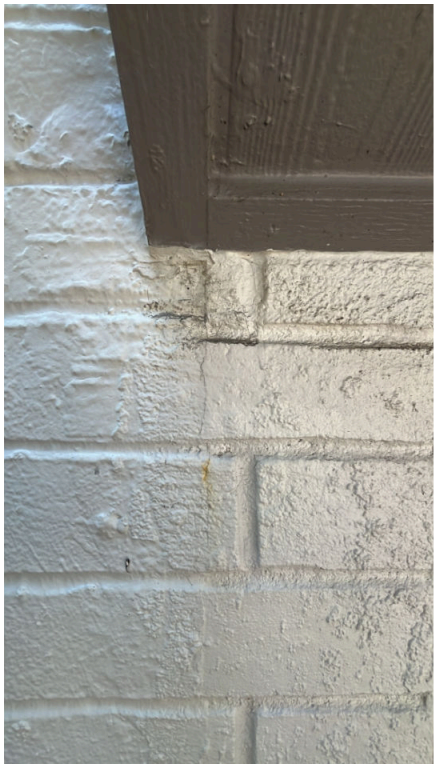
Media 10: Building 50, unit 1008, crack in wall reflecting through a previous repair starting at the architectural bump-out
