PEPPERTREE BAY BLDG 51

RESERVE STUDY

July 2024
Report Prepared By:

DYNAMIC ENGINEERING
DESIGN & INSPECTION

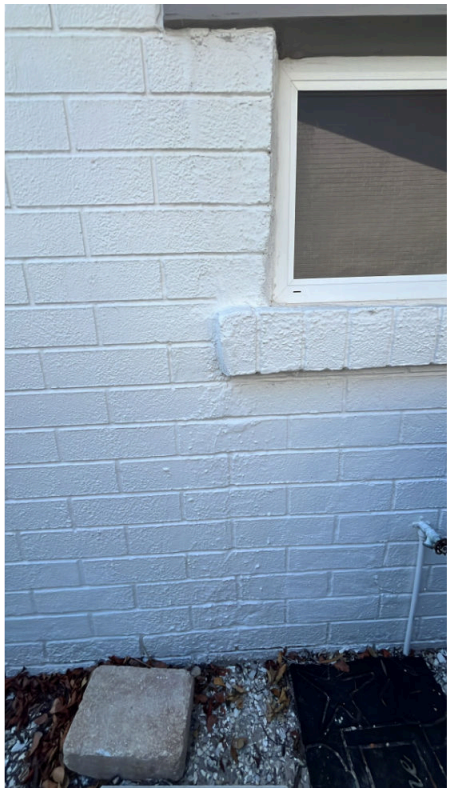
Media 9: Building 51, unit 1009, side elevation. Previously repaired crack which is reflecting back through the caulking or grout placed over the original crack.

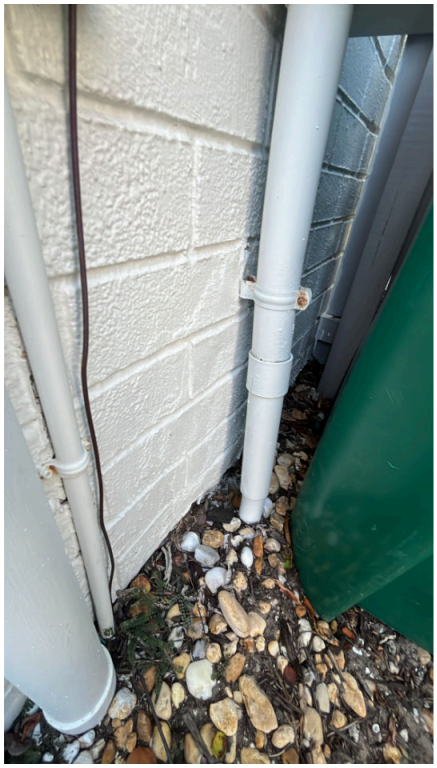
Media 10: building 51 unit 1009 slight bulge at the bottom of the veneer
