PEPPERTREE BAY BLDG 53

RESERVE STUDY

July 2024
Report Prepared By:

DYNAMIC ENGINEERING
DESIGN & INSPECTION

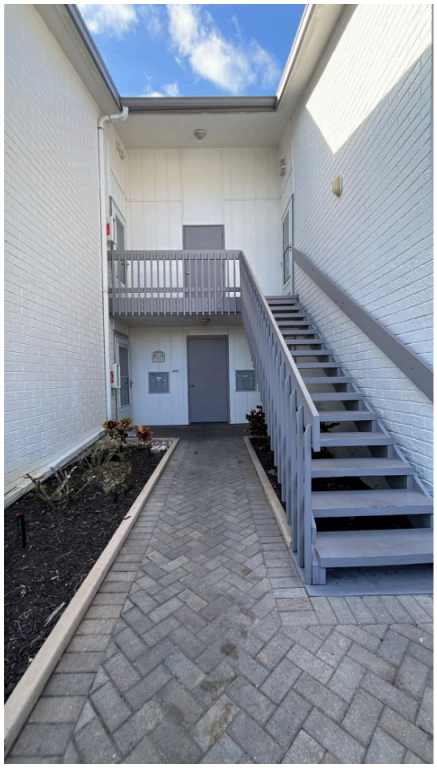
Media 6: Building 53, stairwell between units 1036 and 1040.
